RELATION H/T IN STRUCTURES OF BAHÍA DE CARAQUEZ AND THE 2016 EARTHQUAKE

R. Aguiar ^(1,2), V. Zambrano ⁽²⁾

RELACIÓN H/T EN ESTRUCTURAS DE BAHÍA DE CARÁQUEZ Y EL TERREMOTO DE 2016

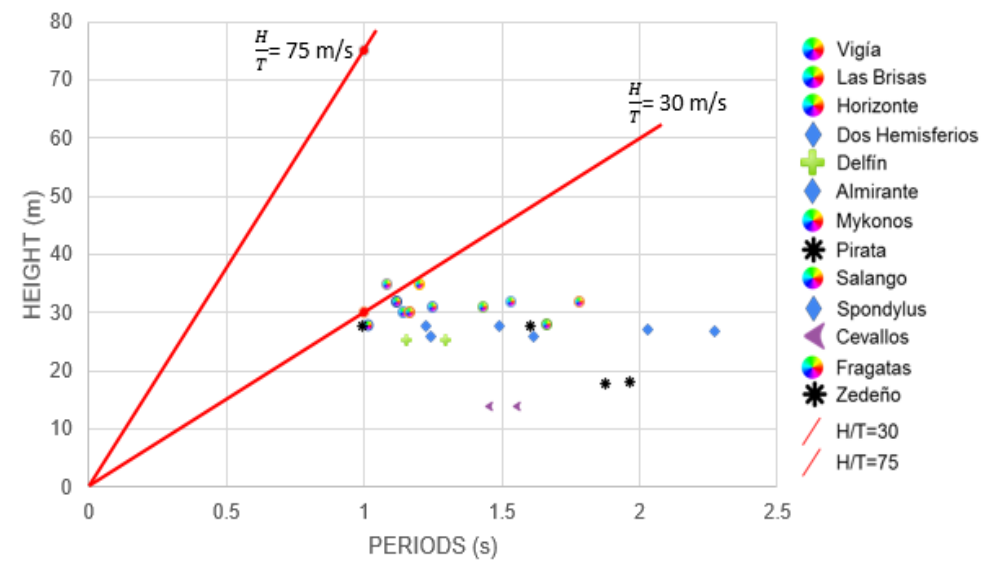
Figure 16 Relationship H / T found in buildings of Bahía de Caráquez, earthquake post 16 A. Source: This study.

Figure 16 shows the values of the height of the buildings H and the experimentally found period, after the earthquake of April 16, 2016, it is seen that most of the points are at the bottom of the curve $\frac{H}{T} \leq 30$, which corresponds to flexible structures.
